## Ride Height Adjustment

Mercedes E-class W211 / S211

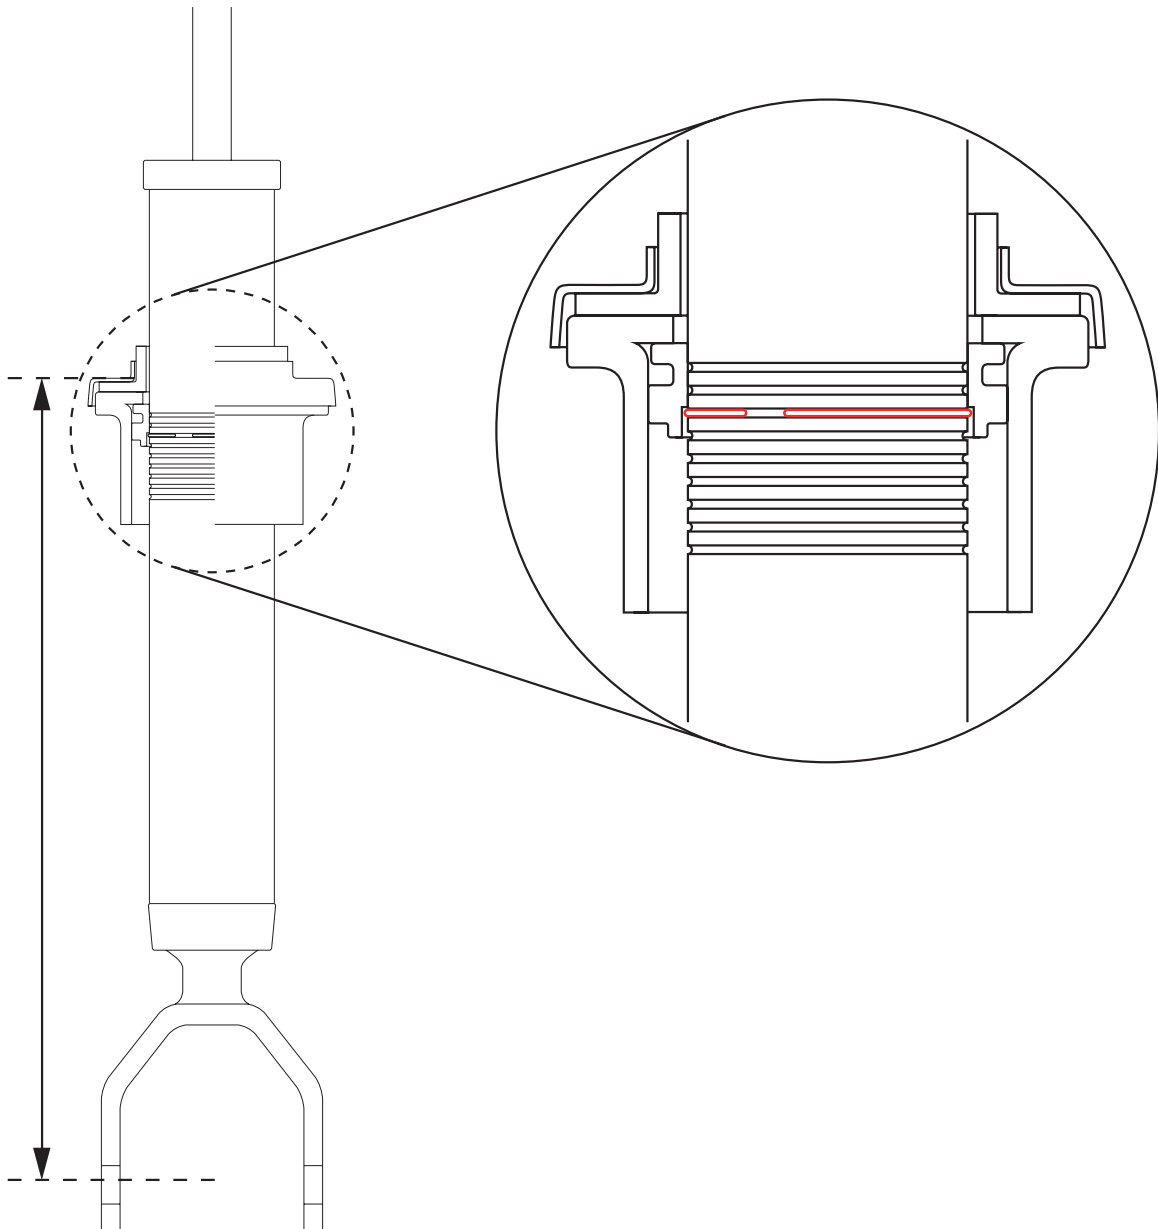
To adjust the spring pan, move the supporting ring (circlip) into the corresponding groove (see image).

Ensure that the height of the spring pan on the new shock absorber matches the height of the spring pan on the shock absorber which is being replaced.
